A Decade of Performance of FRP-Repaired Concrete Structures

Shamim A. Sheikh and S. Mukhtar Homam
Department of Civil Engineering
University of Toronto
Toronto, Canada

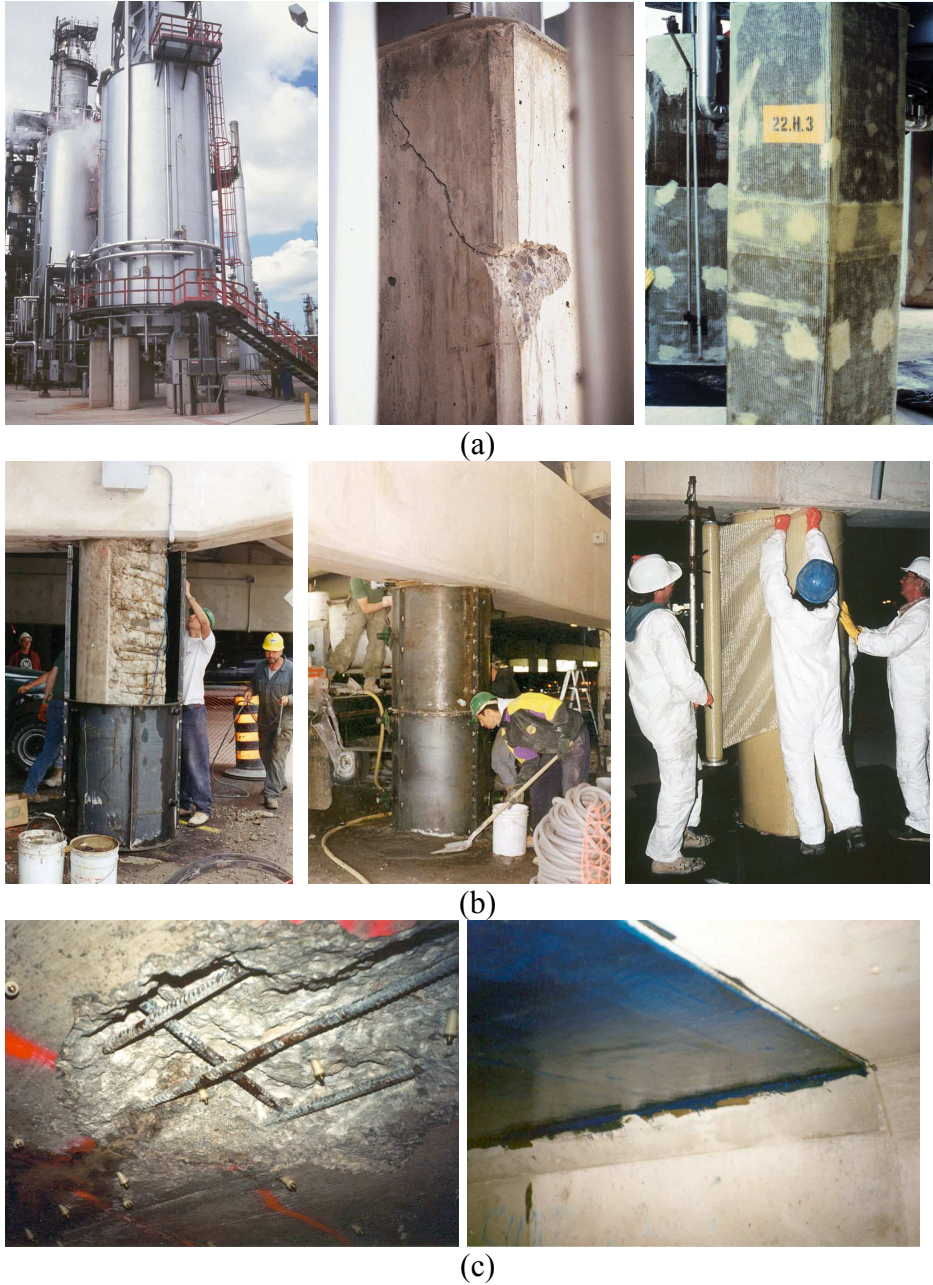
Eight reinforced concrete columns in a platform for a pre-heater unit in an oil refinery were damaged during construction and further deteriorated due to severe environmental conditions (Fig. 1). The columns, 610 mm square in cross-section, were first repaired with non-shrink grout and then wrapped with two layers of GFRP. Corners of the columns were rounded off to 35 mm radius before the wraps were applied. The structure is being inspected and monitored regularly. The wrapped columns have been subjected to severe environmental effects that include severe exposure to chemicals typical of an oil refinery for about 10 years and have not shown any deterioration. Several bridge columns were strengthened with carbon and glass FRP in and around Greater Toronto Area. Fig. 1 also shows a few of the repaired columns along Highway 401. In addition, bridge culverts along QEW in Burlington, also shown in Fig. 1, were upgraded with CFRP to enhance their load carrying capacity.

Figure 1: Structures repaired with FRP: a) oil refinery, b) highway bridge columns, and c) highway bridge culverts.

The entire bridge was repaired in 1996. Three columns were repaired using three different repair schemes and monitored over several years. Concrete cover had spalled off in all the columns. No attempt was made to remove the contaminated concrete from the columns. Only the loose concrete that could be removed without using any force was taken away from the columns. Fig. 1b shows steps during the repair operation.

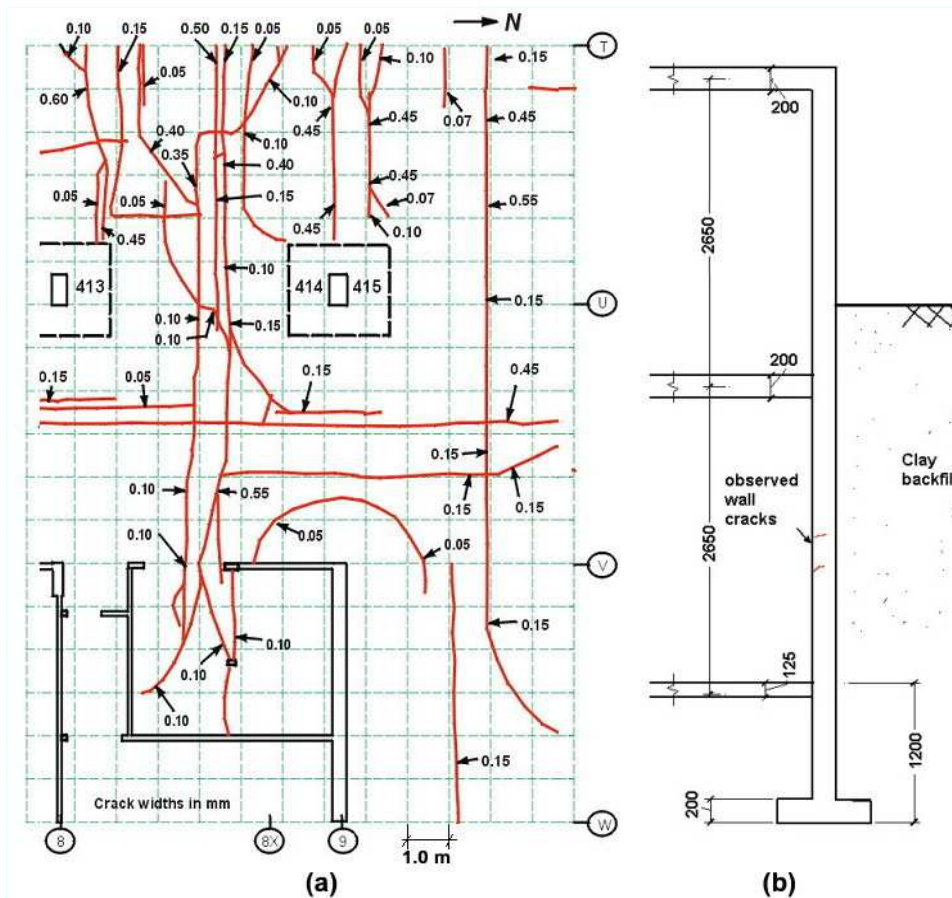
Three years after the completion of the building, maximum crack width in extensively cracked areas of slab was 0.6 mm (Fig. 3a). At several locations cracks in the suspended slabs and walls extended the entire 80m length of the building. The maximum

width of the cracks in the walls was 1.4 mm. Of particular concern were the two horizontal cracks in each of the two north-south walls in parking levels P3 and P4. These cracks were located in the area of the maximum moment generated by the pressure from the retained soil (Fig. 3b). Initially the horizontal cracks were observed to vary from hairline to 0.1 mm in width but at about 30 months after construction, the crack widths at some locations was measured to be 0.70 mm.

Figure 3: Observed cracks in a) slab and b) foundation wall

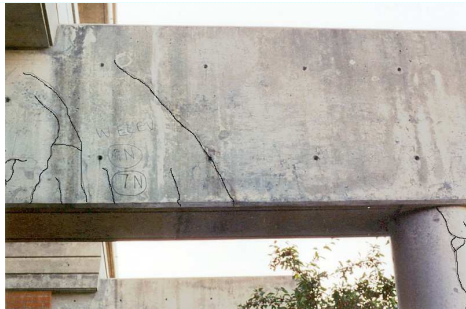
Several transfer beams were cracked but the beams (#1 in Fig. 2) located on two sides of the main entrance to the building showed extensive diagonal cracking (Fig.4). The maximum crack width in the beams was 0.7 mm when the building was less than four years old. Several columns supporting external ends of the beams displayed a number of horizontal cracks with width ranging up to 0.2 mm. In the tests carried out to simulate the behaviour of beams, walls and slabs, it was observed that steel crossing a 0.3 to 0.4 mm wide crack had yielded. The average tensile strain of steel was measured to be 0.0033 corresponding to a crack width of 0.4 mm in the slab tests (1).

Figure 4: Diagonal cracks in the beam

The primary factor in the selection of retrofitting technique was the minimization of interference in normal lives of the residents. Retrofitting with CFRP was selected as the preferred method. As mentioned above, full-scale tests were carried out on beams and slabs before carrying out the field applications. Sample results from two beams tests, shown in Fig. 6, clearly demonstrate the beneficial effects of retrofitting. The brittle shear failure was suppressed with one layer of one mm thick CFRP wrap around the section and the beam behaved in a very ductile flexural manner. The materials and techniques used in the laboratory tests were employed to retrofit beams and walls in the building. Fig. 7 shows a typical beam and a column just after wrapping with CFRP. Walls were retrofitted with 300 mm wide CFRP sheets at 300 mm clear spacing to act as flexural reinforcement. The repaired components have performed without any problems during about four years since repair.

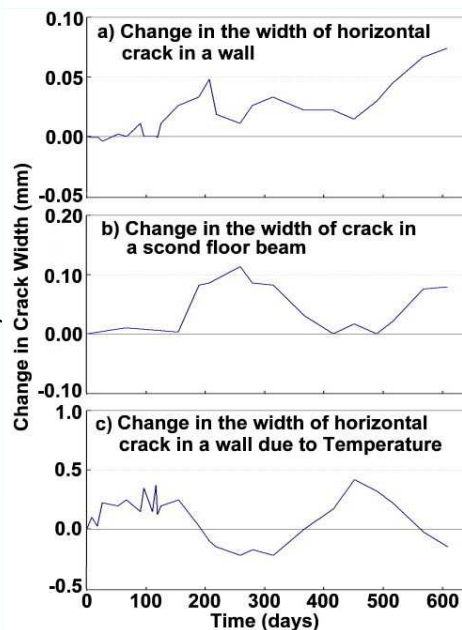
Figs. 5a and 5b show, respectively, changes in the width of a horizontal crack in a wall and a diagonal crack in a beam for about 600 days. The calculated change in the width of the wall crack as a result of temperature variation is plotted in Fig. 5c. It is obvious that the changes in crack widths in the wall and the beam do not correspond to changes in temperature indicating that these cracks are active and growing. From Fig. 5a and 5c, it can be seen that the wall crack grew by about 0.25 mm over a period of 600 days. Similar growth was also observed in beam cracks.

Figure 5: Crack growth wall and beam

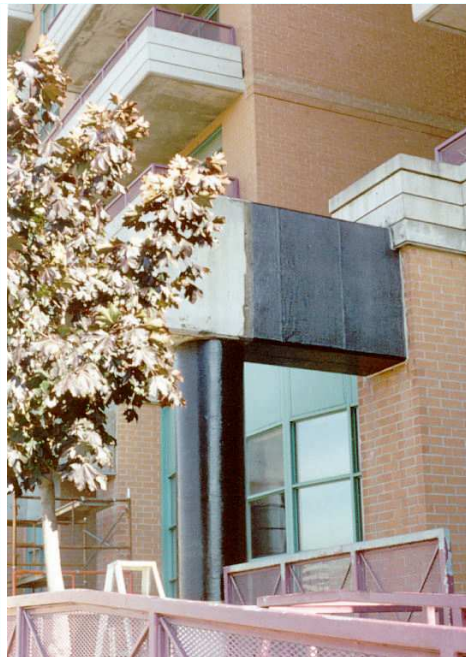
Figure 7: Structure retrofitted with CFRP

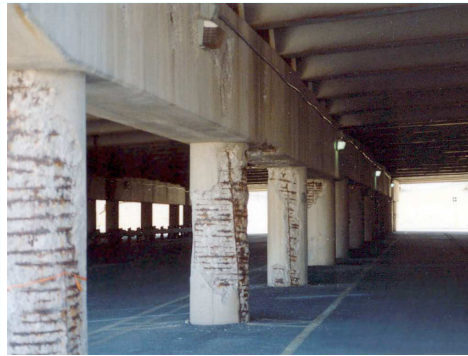
The second case study detailed here is related to a bridge on Highway 401 in Toronto that was damaged primarily by the chlorides from the de-icing salt (Fig. 8). The columns are about 920 mm to 1010 mm in diameter. Most of the damage in the bridge was concentrated at the bents that are directly below the expansion joints where the joint sealant and other materials deteriorated due to extreme weather conditions and the chemicals from the de-icing salts. This allowed the water-ice-salts solution to pass through the joints to the reinforced concrete bents. As a

result of steel corrosion, the cover concrete in columns and girders was delaminated. The spiral steel was corroded severely but the longitudinal steel bars were relatively healthy. From the tests on half-scale models of the bridge columns, the damage similar to the one shown in Fig. 8 reduced the axial load carrying capacity by about 20%-22% (4) as shown in Fig. 9. The GFRP-repaired column was able to recapture the lost strength as well as enhance the ductility of the column exceeding the performance of the original companion specimen. The field columns were subsequently repaired using the schemes developed from the test series.

Figure 8: Damaged highway bridge

Column 1 was repaired with expansive concrete grout using steel formwork (5,6). The expansive cement used was developed for special applications and has the setting properties similar to those of Normal Portland cement thus avoiding the flash set typical of most available expansive cements. About twenty hours after grouting, the formwork was removed and the column was wrapped first in polyethylene sheet and then with two layers of GFRP with fibres aligned in the circumferential direction. The polyethylene sheets were installed to avoid direct contact between GFRP and fresh concrete in an effort to minimize the effects of alkali on glass fibres. Two days after the FRP application, the column was instrumented with six strain gauges in the circumferential direction installed on FRP. Three sets of two gauges each were 750 mm apart vertically in the middle of the column height.

Column 2 was repaired using a non-shrink concrete grout that was pumped in place. Four days later, the steel forms were removed and the column was wrapped in polyethylene sheet and two layers of GFRP. Eight days after the application of the grout, the column was instrumented in a manner similar to that for Column 1. Column 3 was patched using a rheoplastic mortar. A protective epoxy coating was applied six days later followed by the GFRP wrapping and instrumentation similar to that in Column 1. The gauges were applied eight days after the grout application.

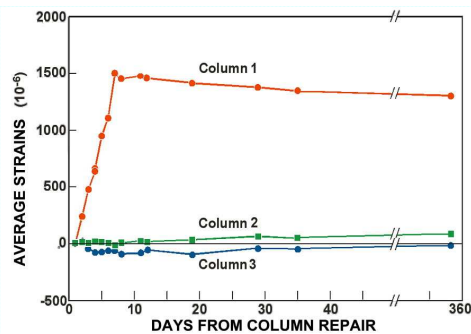
Figure 10: Lateral strain in repaired columns

Lateral strain data from the field columns is shown in Fig. 10. As expected, column 1 with expansive cement cover showed substantial expansion, while no significant lateral strain was measured in FRP in the other two columns. The maximum expansion in column 1, approximately 0.16%, was observed ten days after grouting. Lateral strain in GFRP remained fairly constant at about 10% of its rupture strain for over a year when monitoring of this data was terminated indicating stable expansive cement behaviour and no significant creep of GFRP.
