LONG-TERM PERFORMANCE MONITORING OF GFRP-REPAIRED BRIDGE COLUMNS

Shamim A. Sheikh and S. Mukhtar Homam
Department of Civil Engineering
University of Toronto
Toronto, Canada

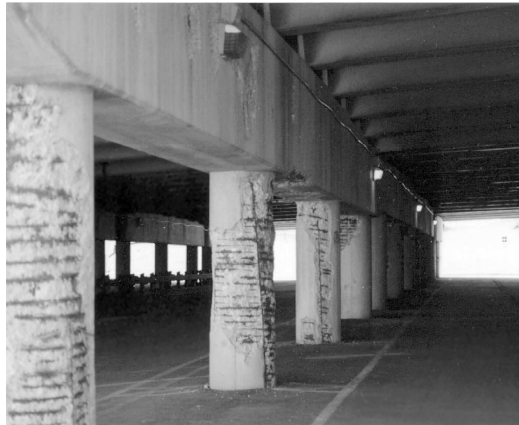
Figure 1: Damaged highway bridge

The damage was mostly concentrated at the bents that are directly below the expansion joints. The joint sealant had deteriorated with time, allowing the de-icing salt solution to soak the reinforced concrete bents. Accumulation of this solution at the bent top and its continuous flow downward along the columns resulted in deterioration of concrete as well as corrosion of steel. The columns were also exposed to salt attacks from the cars using the area under the bridge as a parking lot. The structure is also subjected to usual Toronto environmental effects that include freeze thaw cycles, wet dry cycles, temperature variations, etc. The spiral steel in the columns and tie steel in the beams severely corroded as a result of this exposure. The expansive forces thus generated caused the cover concrete in both columns and girders to be severely delaminated.

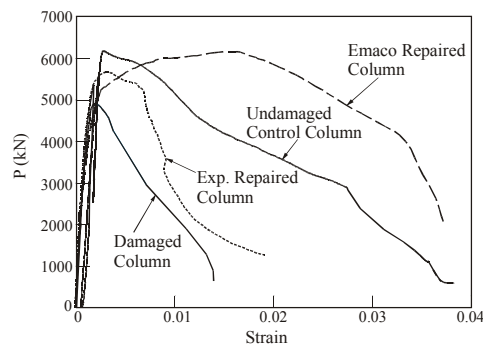
It can be seen from Fig. 2 that the damaged column had about 20% lower strength and substantially lower ductility and energy dissipating capacity than the undamaged control column. The corrosion rendered the spiral steel completely

Figure 2: Behaviour of columns under axial load

ineffective in the damaged columns. Pitting corrosion of spiral reduced its effectiveness for confinement and caused its rupture at relatively small column strain.

Behaviour of repaired specimens was significantly better than that of the damaged unrepaired specimen. The axial load carrying capacity of the Emaco-repaired specimen was as large as that of the control undamaged column and its ductility and energy dissipation capacity were substantially better. The Exp-repaired column did not display as good a performance as the Emaco-repaired column. This is due to the fact that at large strains the plastic sheet of the formwork used in the Exp-repaired column opened out and engaged the fibre wrap at both ends, causing large local strain and premature failure of the wrap and the column.

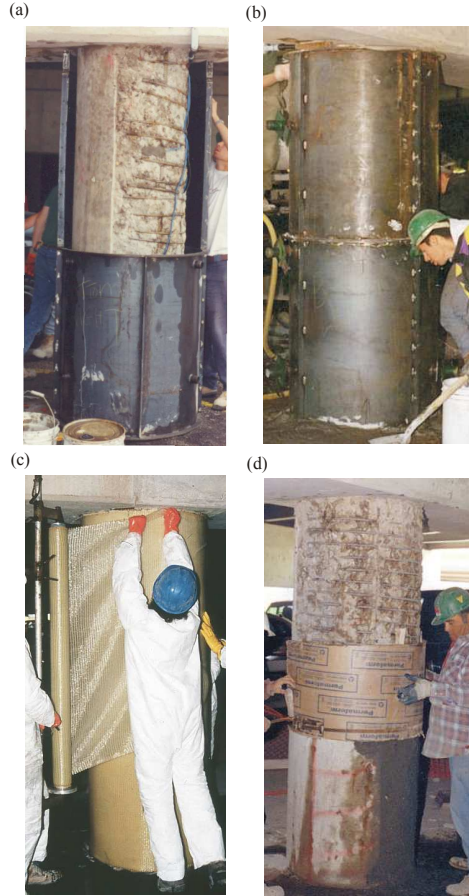
Figure 3: Various steps in column repair

Column 1 was repaired with expansive concrete grout using steel formwork (Figs. 3a and 3b). The thickness of the expansive concrete cover around the column was about 50 mm. The formwork was removed about twenty hours after grouting and the column was

wrapped with a thin polyethylene sheet and then two layers of GFRP with glass fibres aligned in the circumferential direction (Fig. 3c). The polyethylene sheet was used as a barrier between the new concrete and the GFRP and was not expected to affect the column behaviour. Three days after the grouting, the column was instrumented with six strain gauges installed on the FRP in the circumferential direction. Two gauges each, 180° apart, were installed at mid height, 750 mm above and 750 mm below the mid point.

Column 3 was repaired with EMACO-based rheoplastic mortar which did not require and formwork (Fig 3d). A protective epoxy coating was applied six days later followed by the GFRP wrapping. The strain gauges were applied to this column eight days after grouting/plastering.

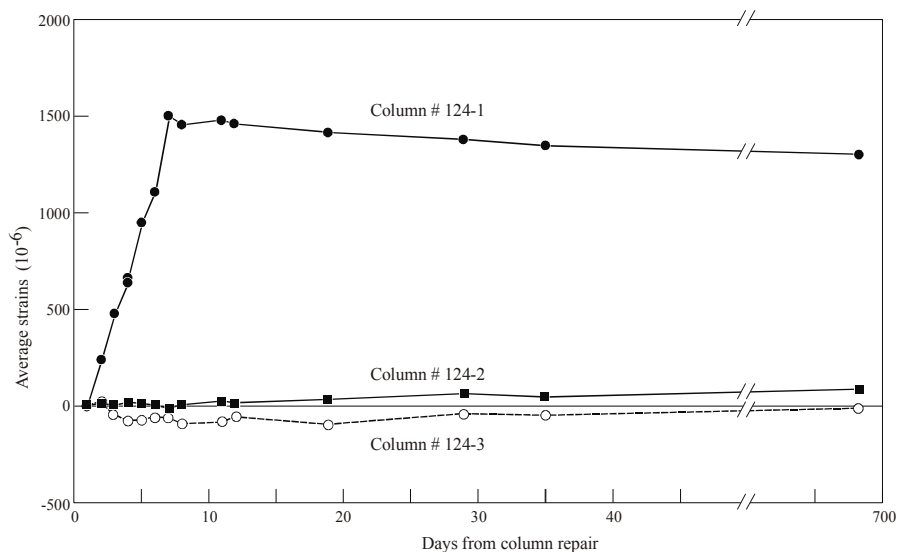
Figure 4 shows variation of lateral strain with time from the field columns. As expected, Column 1 showed substantial expansion while no significant lateral strain was measured in FRP in Columns 2 and 3. The maximum expansion in Column 1, approximately 0.16%, was observed ten days after grouting and represents about 10% of GFRP rupture strain. Lateral GFRP strain in the three columns remained fairly constant for about two years indicating stable expansive cement behaviour and no significant creep of GFRP. Recording of strain data was terminated about two years after the repair.

Figure 4: Lateral strain in GFRP in repaired columns

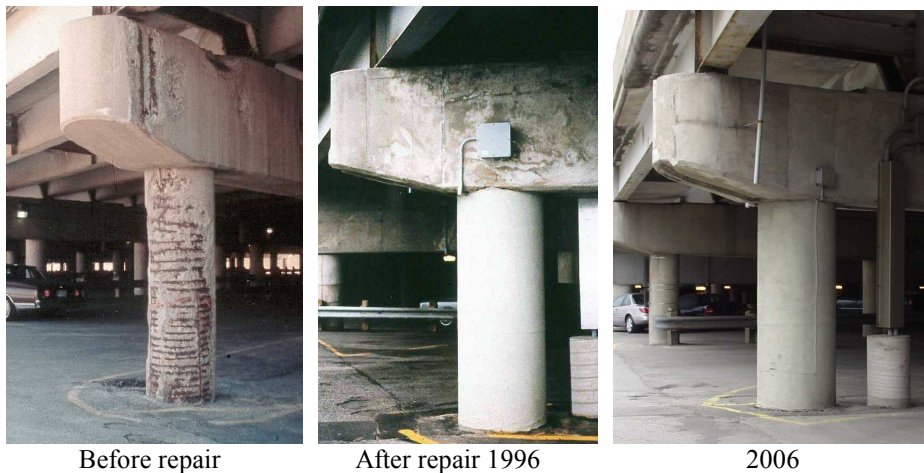
Field data on strain and corrosion rate and physical inspection over eleven years indicated a sound performance of the retrofit techniques used for the columns. Figure 5 shows Column1 before repair, soon after repair and in 2006. No deterioration was observed in any of the columns and risk of future corrosion has also reduced. There has also been no need to repeat the repair process in any of the columns repaired more than eleven years ago. In this first GFRP repair exercise, a thin polyethylene sheet was used in some columns as a barrier to separate new mortar or concrete from the GFRP to avoid any possible adverse effects of alkalis on the performance of GFRP in the long term. Since then, extensive testing has shown excellent long-term performance of GFRP sheets under alkaline environment (4, 9-11). Future repairs using GFRP can thus be carried out without the use of barriers. Although the presence of the barrier is not necessary for isolating glass from alkali, the barrier might have contributed toward the reduced corrosion activity in the columns.

Figure 5. Columns before and after repair
